3.10.5 Individual Plate Defect Locations

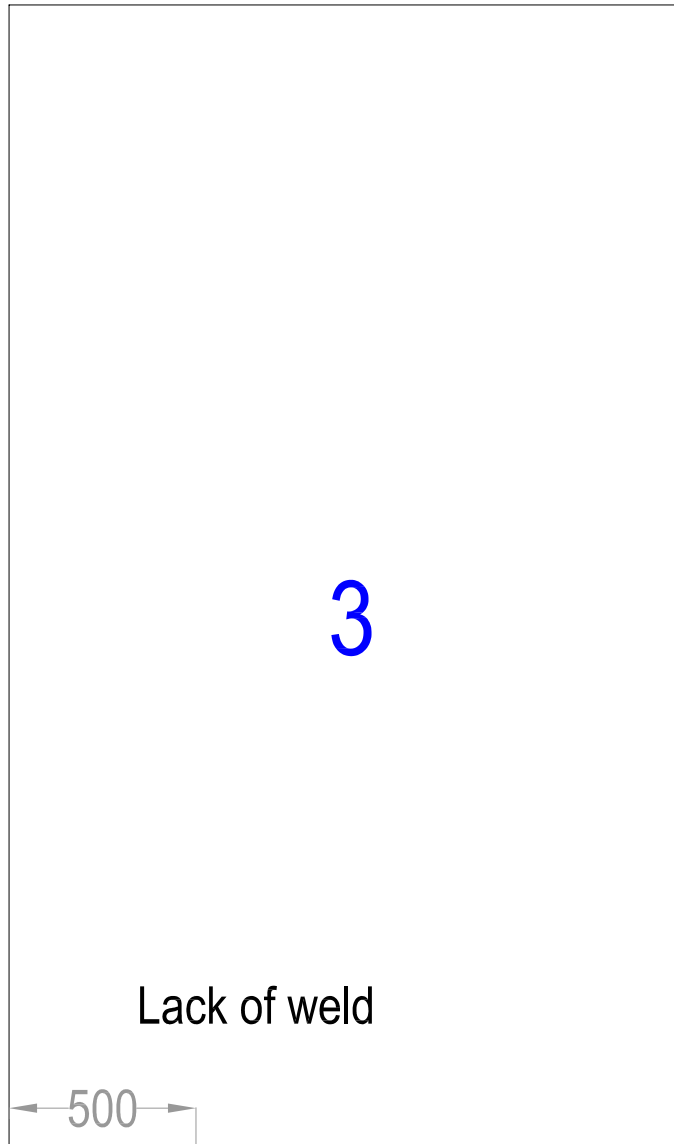
Drawing by:	Drawing Date:	Inspection date:
Client:	Desc: Plate 3	Report #:

Tank Ø = 14.6m  
 Floor Plate Nominal Thickness: 6.4mm  
 Annular Plate Nominal Thickness: 8.0mm
